# XJ Series Forum

## Mr Brighty's Avon Coupe restoration

Back in May, Mr Brighty wrote the background story to his purchase of BML 954T, one of only 4 Daimler Double Six Avon Convertibles. The car has now been at the XjRestorations workshops for much of 2015, and should be on the road by the time this comes to print. In this issue **Keith Parrington** provides a little detail to the restoration work that has been required. A full review of the completed car will follow in a future issue.

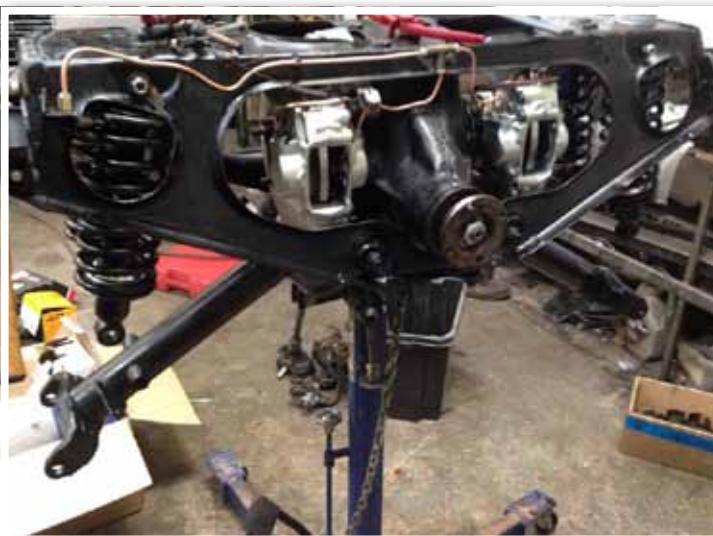
*The rear suspension overhauled and refurbished ready for re-assembly onto the car.*

With the engine signed off as a runner, attention turned to the suspension and brake assemblies. With each sub assembly removed from the body, these Bob Knight units are a joy to work on.

This car is to be a working car, earning its keep, so a concours detail was not on the agenda. Nonetheless, the units were stripped to component parts, washed and painted, and reassembled with all new bearings, seals, joints, brakes and

fixings. The springs and dampers were replaced in their standard form to ensure a luxury waft over a sporty tourer.

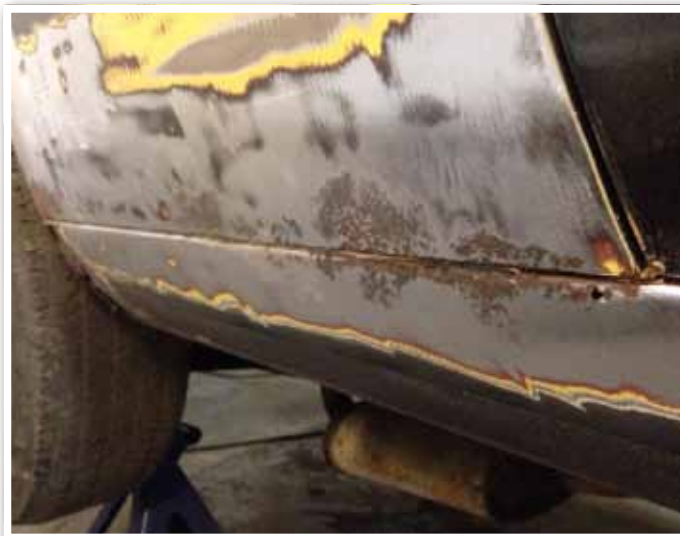
*The extent of some of the corrosion work.*

the roof off a production car inviting further water ingress into a modified structure is rarely going to give you a surprise. On this occasion though, we had just that. With all trim components and paint removed from the vehicle, the repair lists consisted of removing and fabricating the lower rear wing to sill joining section, replacing 3 sill end caps, one rear wheelarch lip, the lower rear centre valance, and the rear centre section of the driver's floorpan. We also replaced the passenger front wing nose cone as a few small pin holes were evident – better safe than sorry.

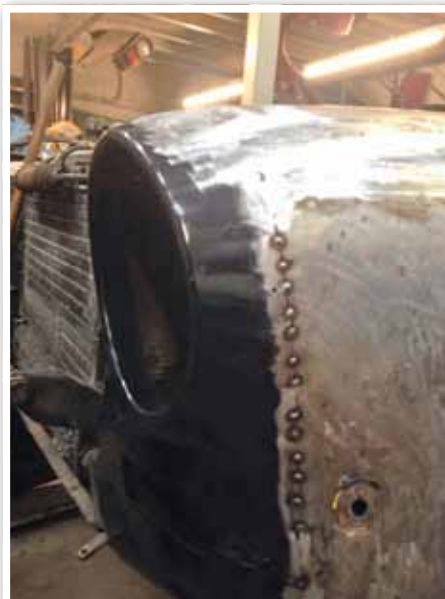
*Fitting of a new nose cone.*

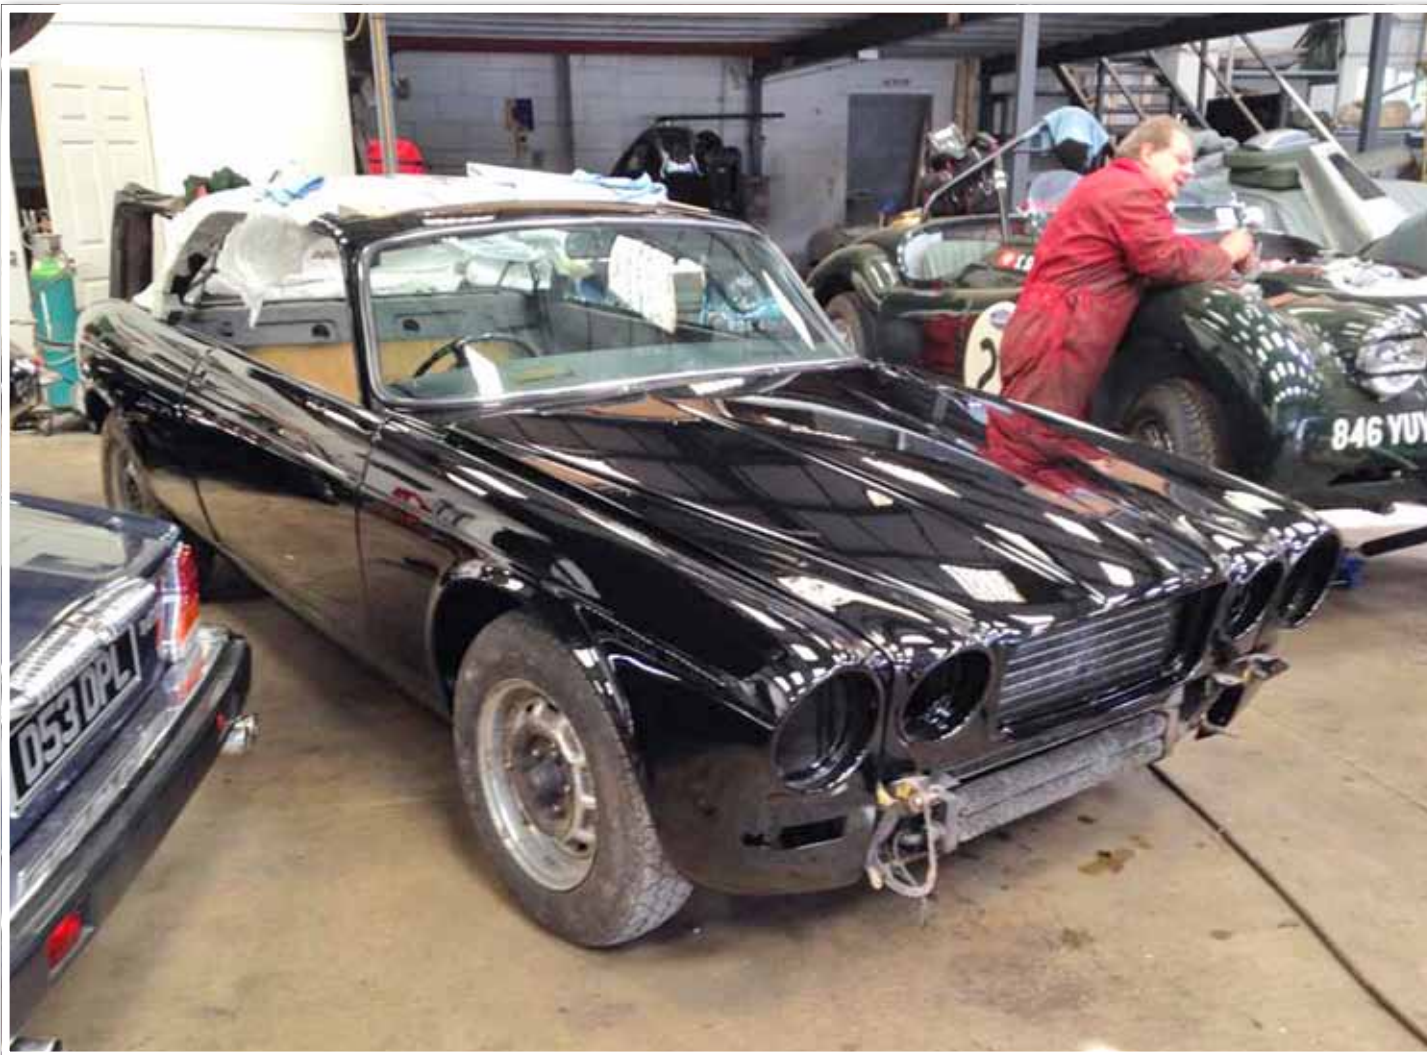
*The body out of the paint shop*

With all repairs lead loaded, and the panels gapped, the car was sent to Nick at Hailsham Autobody ([www.hailshamautobody.co.uk](http://www.hailshamautobody.co.uk)) for a full bare metal respray. The car returned our workshop with a glass finish, ready for a refit.

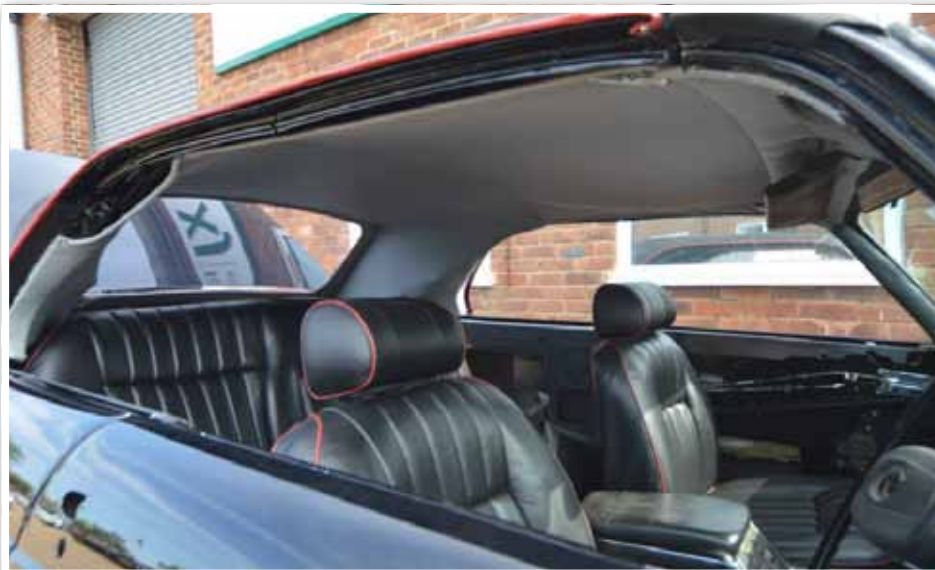
The long stretch inside a dark garage had seen the hood corrode away to nothing, and the frame seize up. Much of the stitching had also dried and let go. Our trimmer of choice and good friend Dave Upton gladly took up the challenge of putting this right. Dave ([www.cauptonandson.co.uk](http://www.cauptonandson.co.uk)) is based near Hastings, and worked on many of the Hasting based Lynx cars including the Lynx version of the Coupe. Even so, the work proved problematic from start to finish due to the lack of thought in the original design and total lack of any pattern. After a head scratching/banging month, the car returned with a fresh interior, and stunning roof.

*Trimming almost complete at this stage.*
